Reaction to fire test report

Test standard: AS ISO 9705:2003 (R2016)

Product: TBA Firefly™ Intubatt® with TBA FIREFLY™ NON-COMBUSTIBLE Sarking-Non-BREATHABLE

Job number: RTF210386

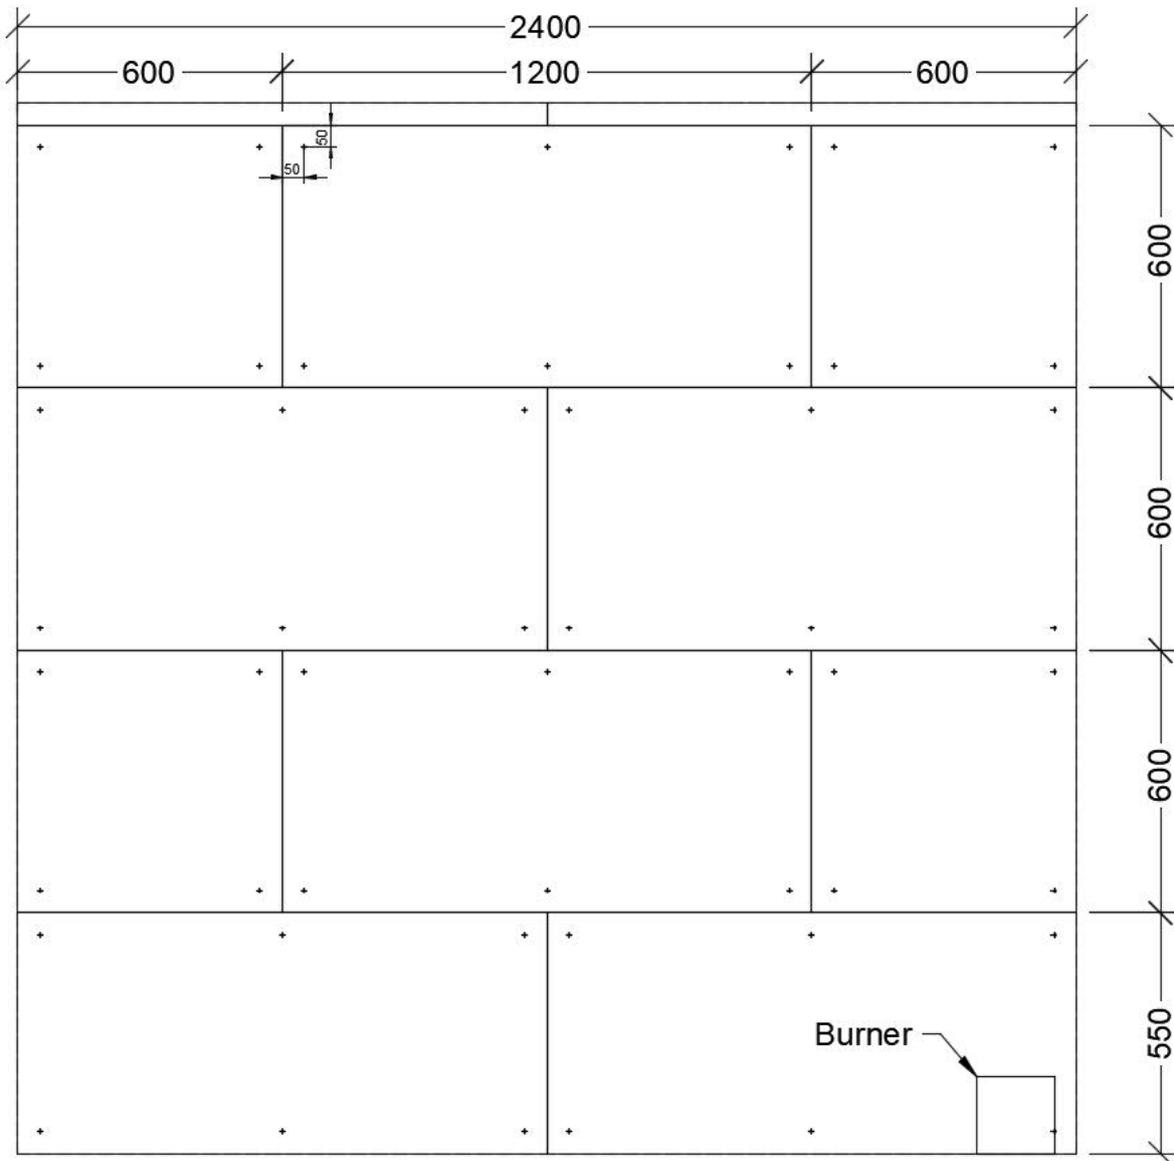
Figure 1 Back wall panel arrangement

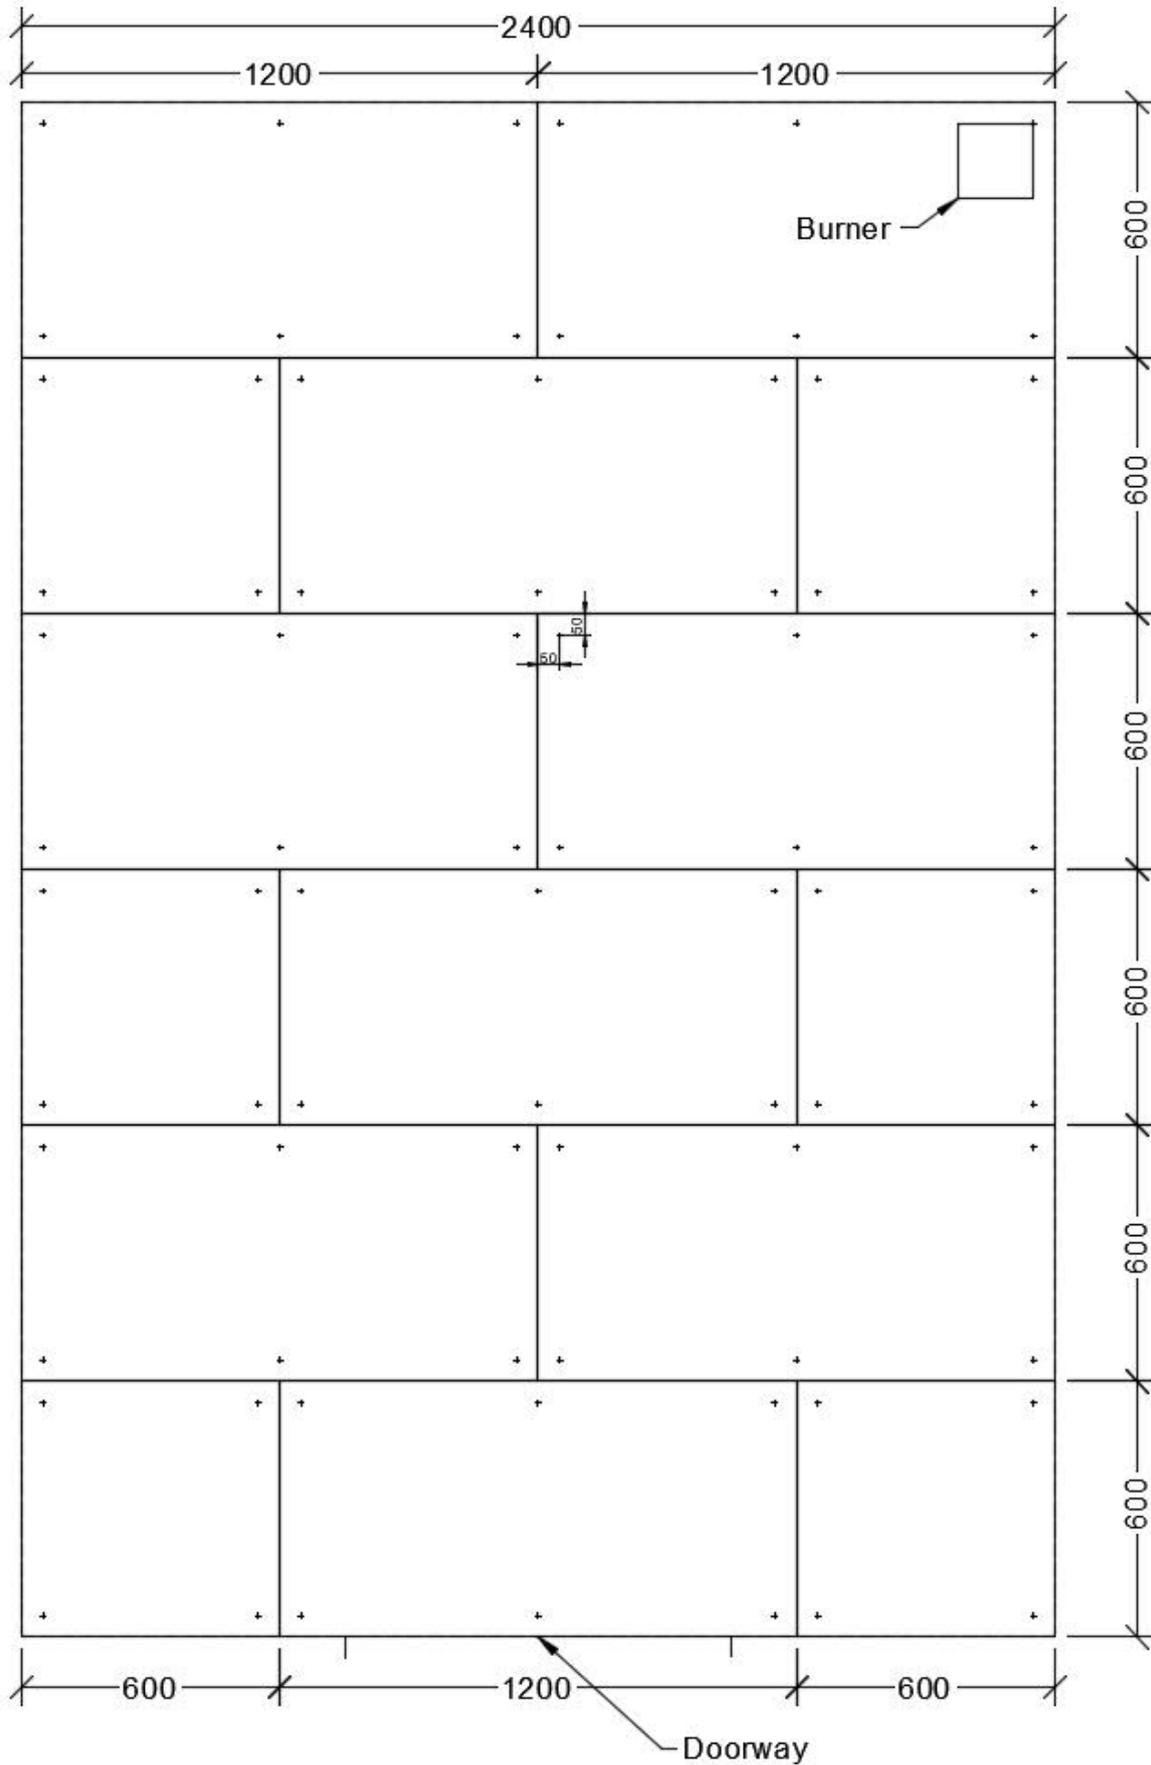
Figure 2 Ceiling wall panel arrangement

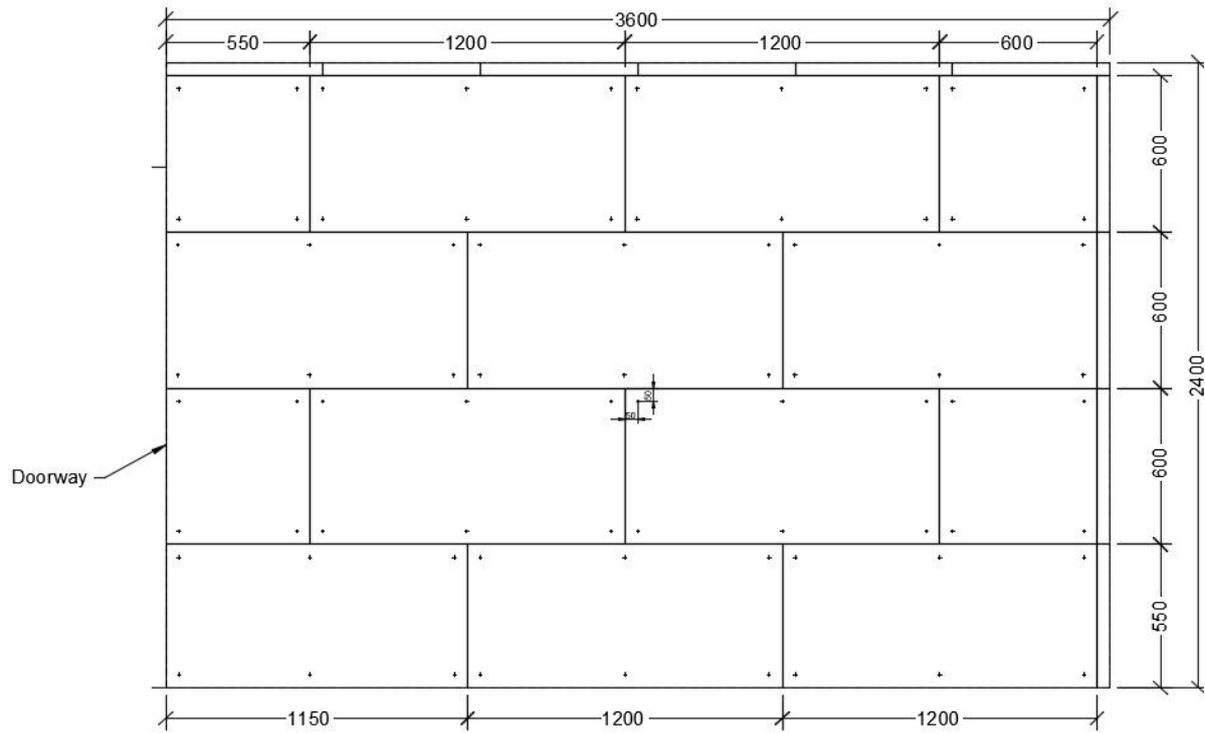
Figure 3 Left wall panel arrangement

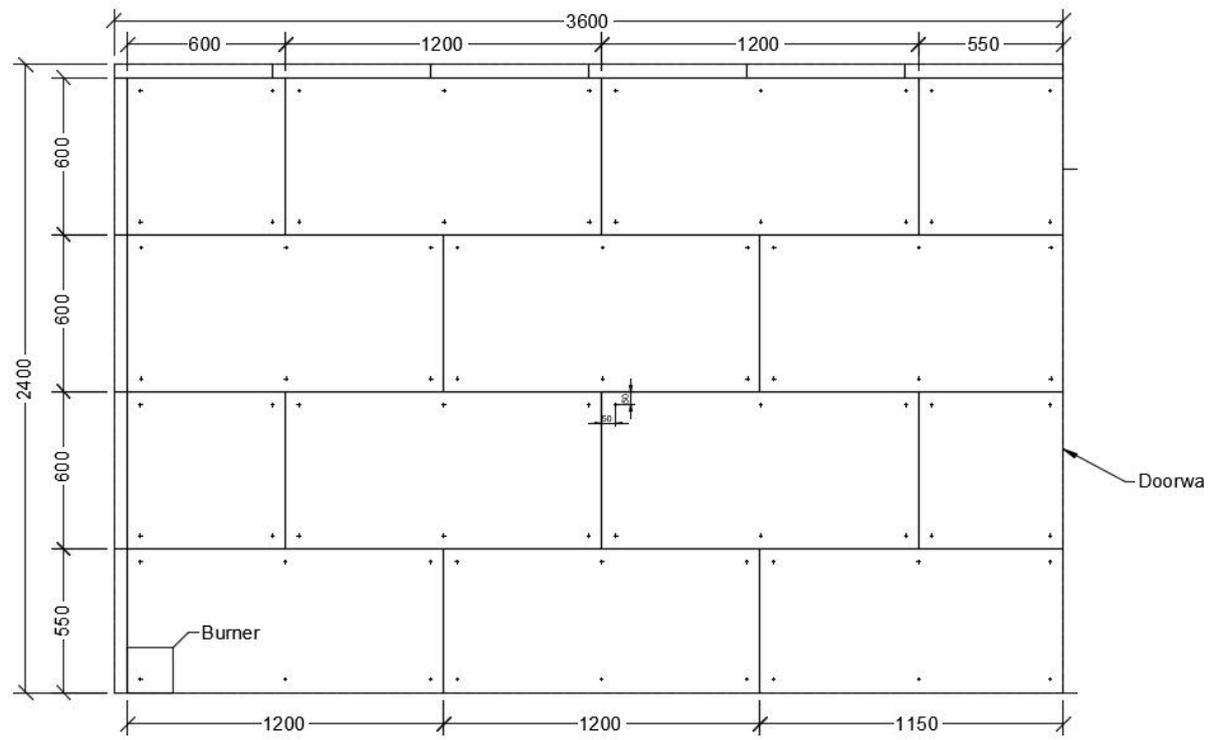
Figure 4 Right wall panel arrangement

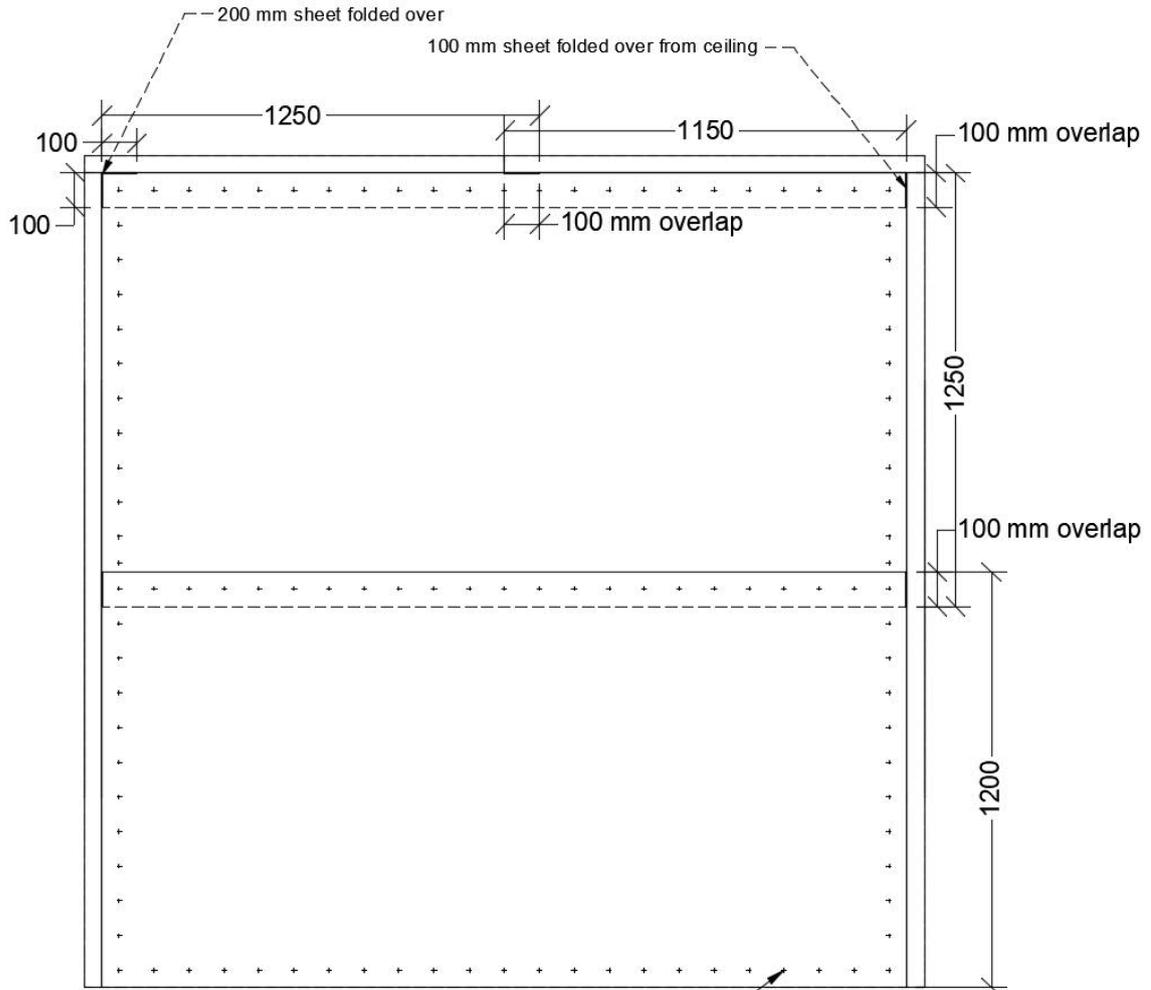
Pigtail screws at 50 mm offset from edges, and 100 mm centres

Figure 5 Back wall – Sarking installation detail

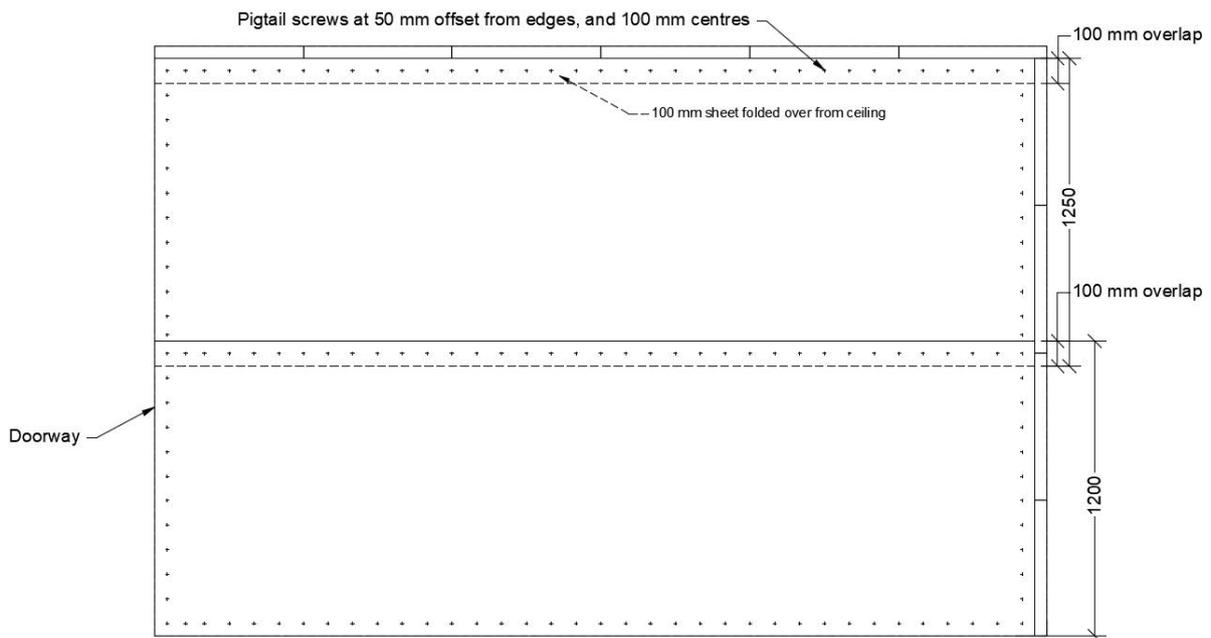
Figure 6 Side walls – Sarking installation detail

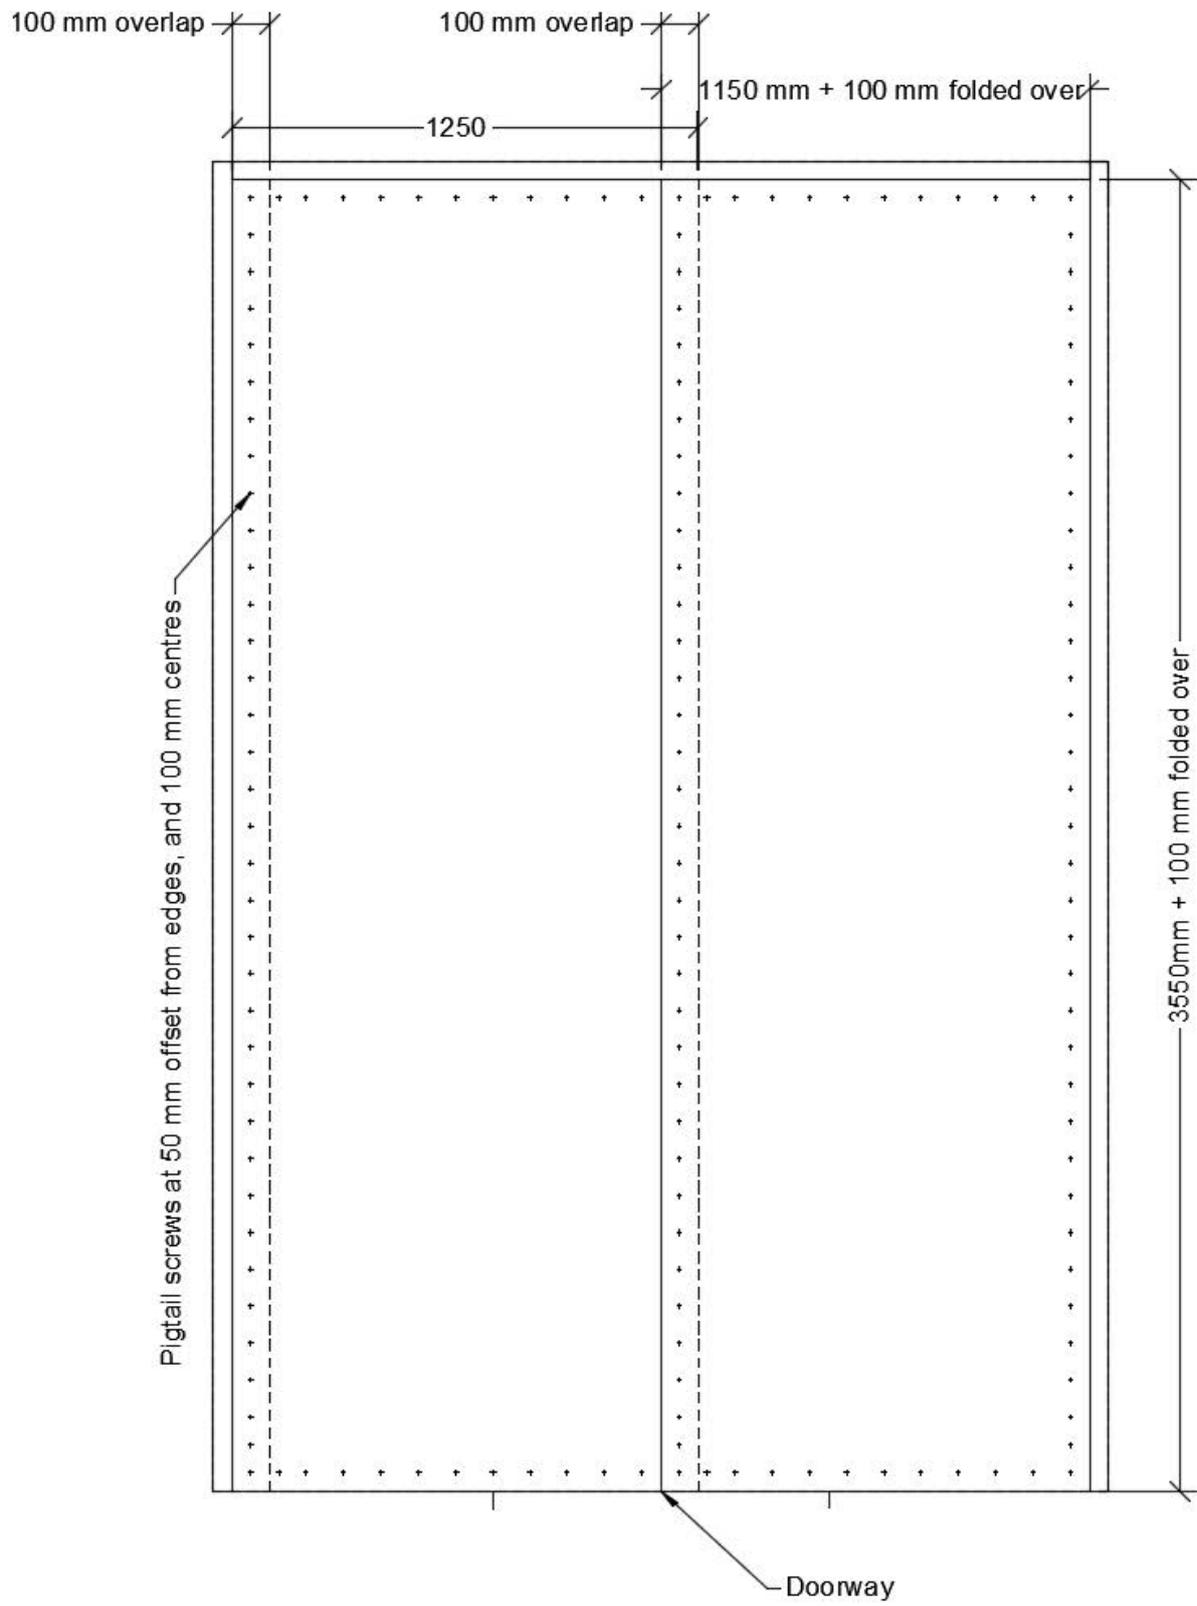
Figure 7 Ceiling (top view) – Sarking installation detail

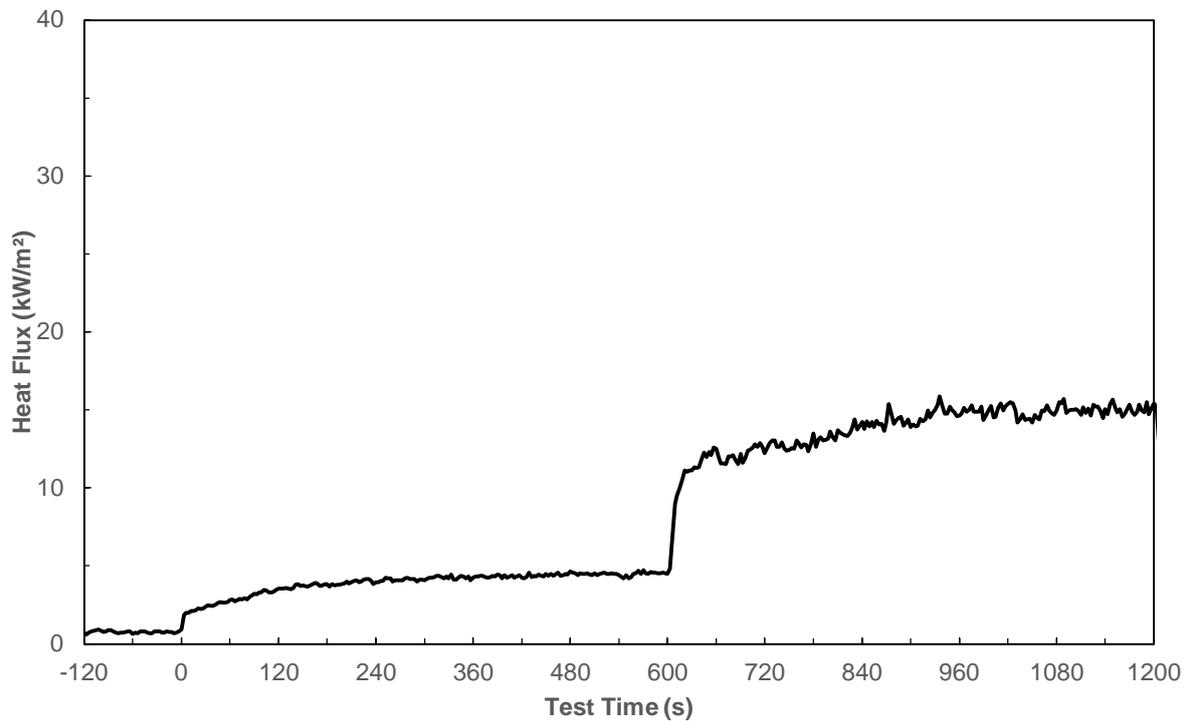
Figure 8 Heat flux vs time

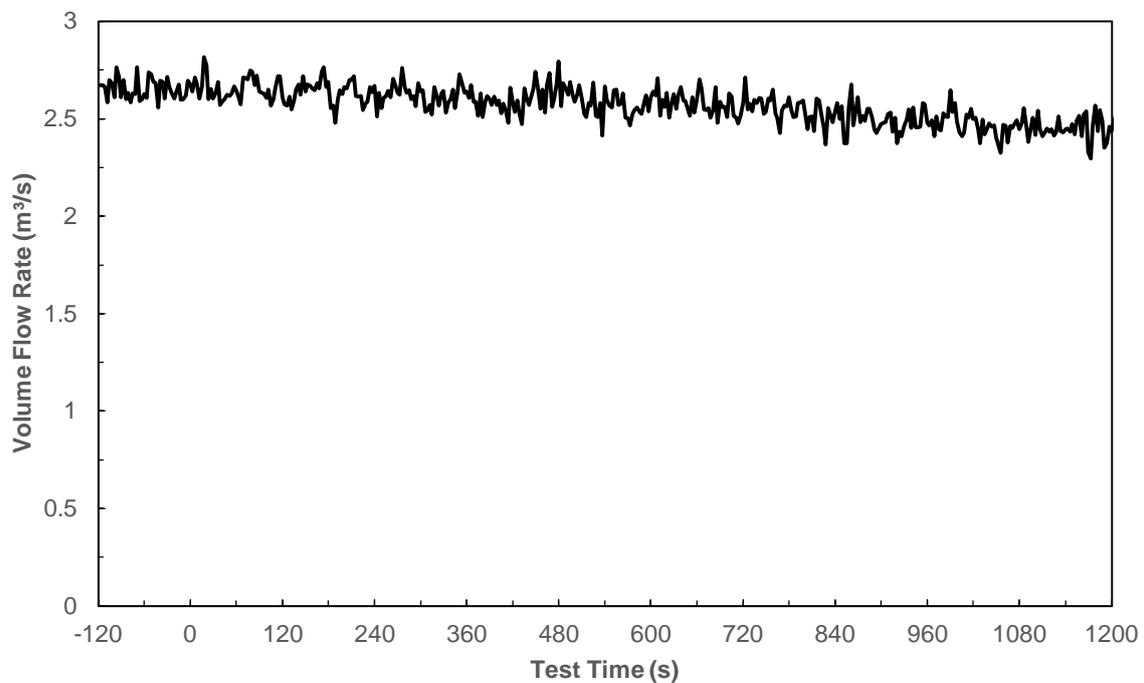
Figure 9 Volume flow rate in duct vs time

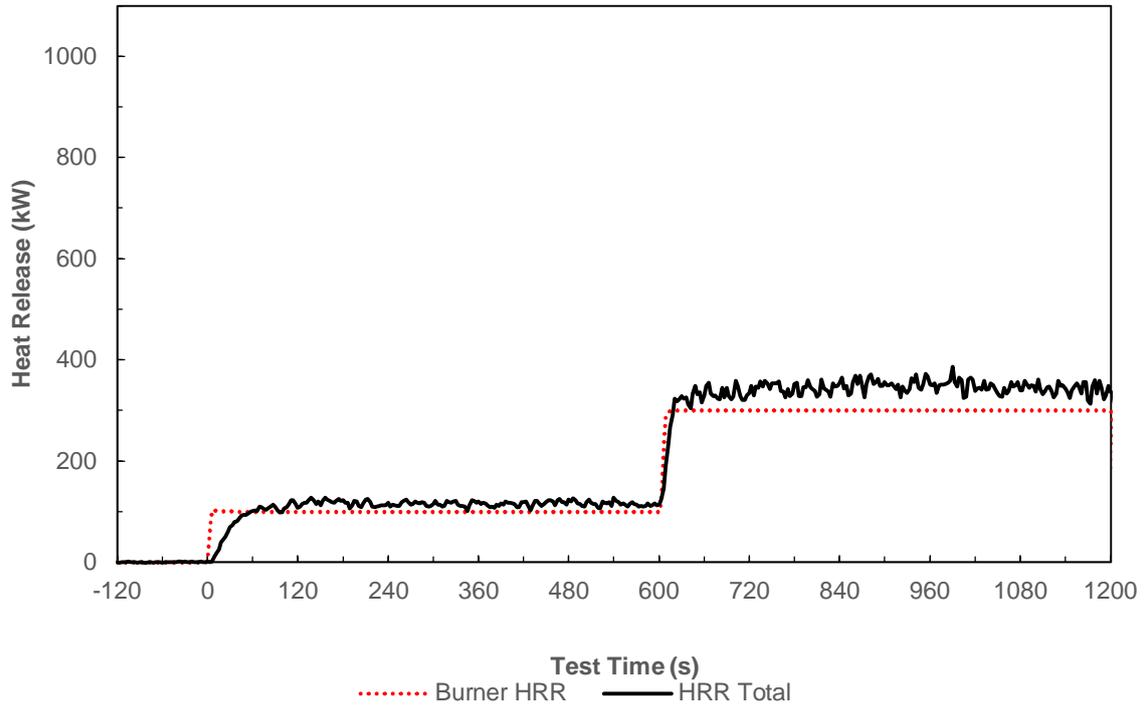
Figure 10 Heat release rate (HRR) of specimen and burner vs time

The material subjected to this AS ISO 9705:2003 (R2016) test did not achieve a heat release rate of 1 MW after 600 seconds exposure to a 100 kW heat source immediately followed by a further 600 seconds exposure to a 300 kW heat source. Therefore, the system has achieved a classification of Group 1.

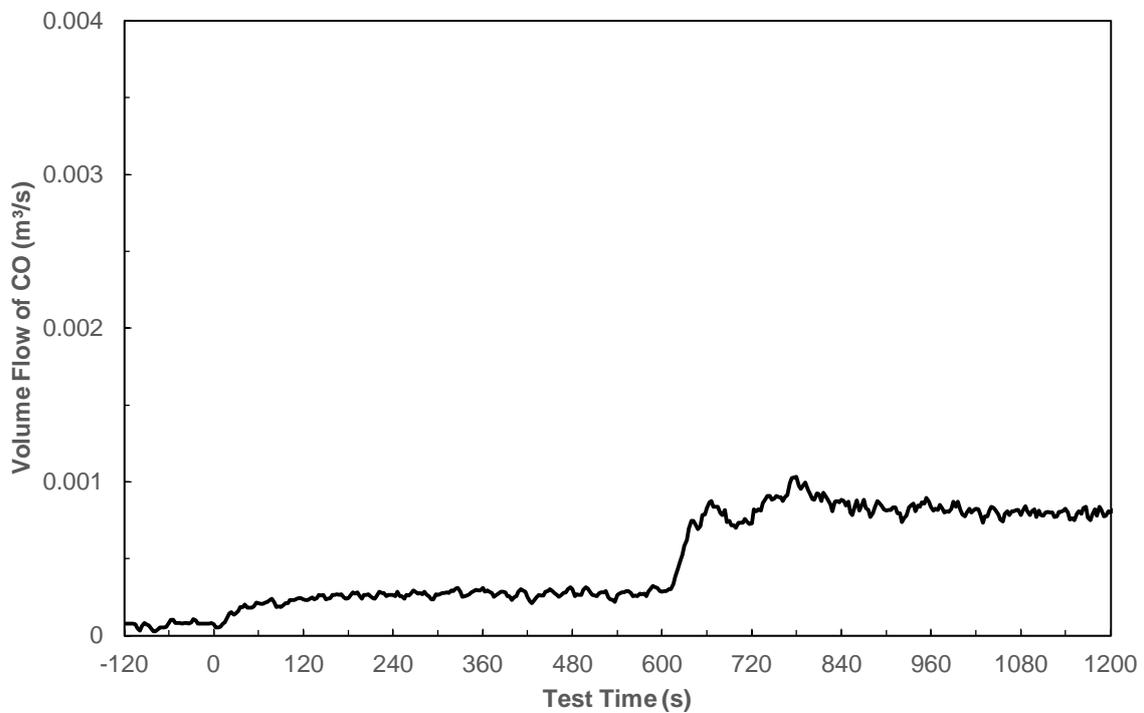
Figure 11 Production of carbon monoxide vs time, at reference temperature and pressure

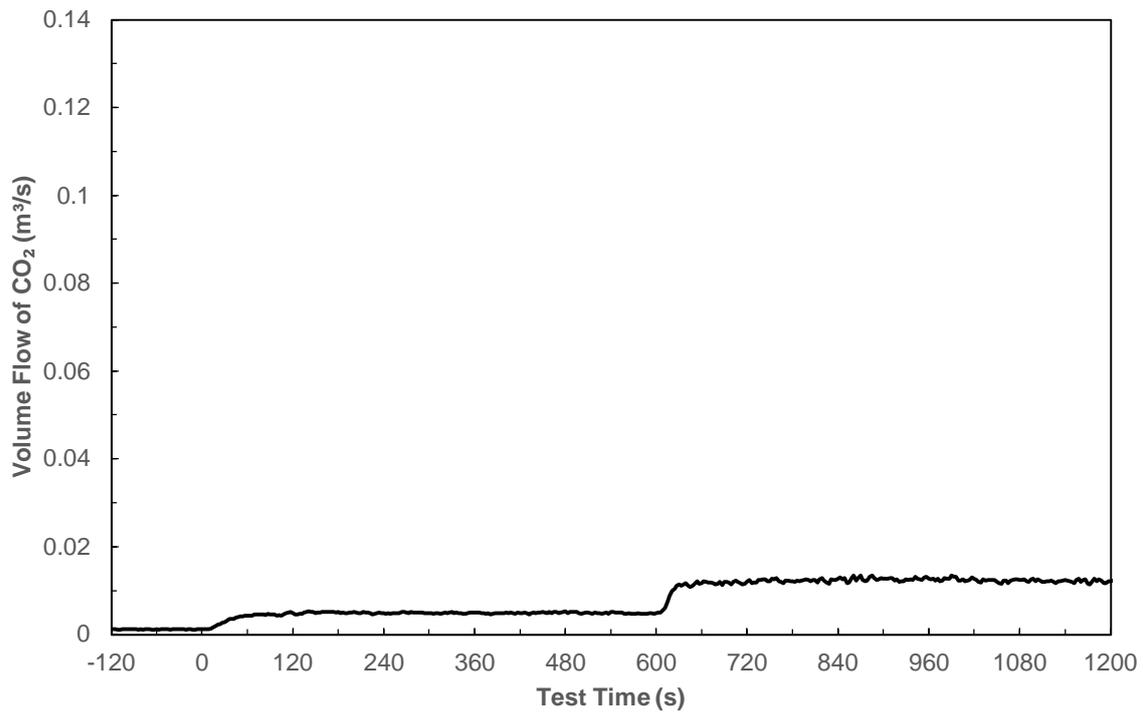
Figure 12 Production of carbon dioxide vs time, at reference temperature and pressure

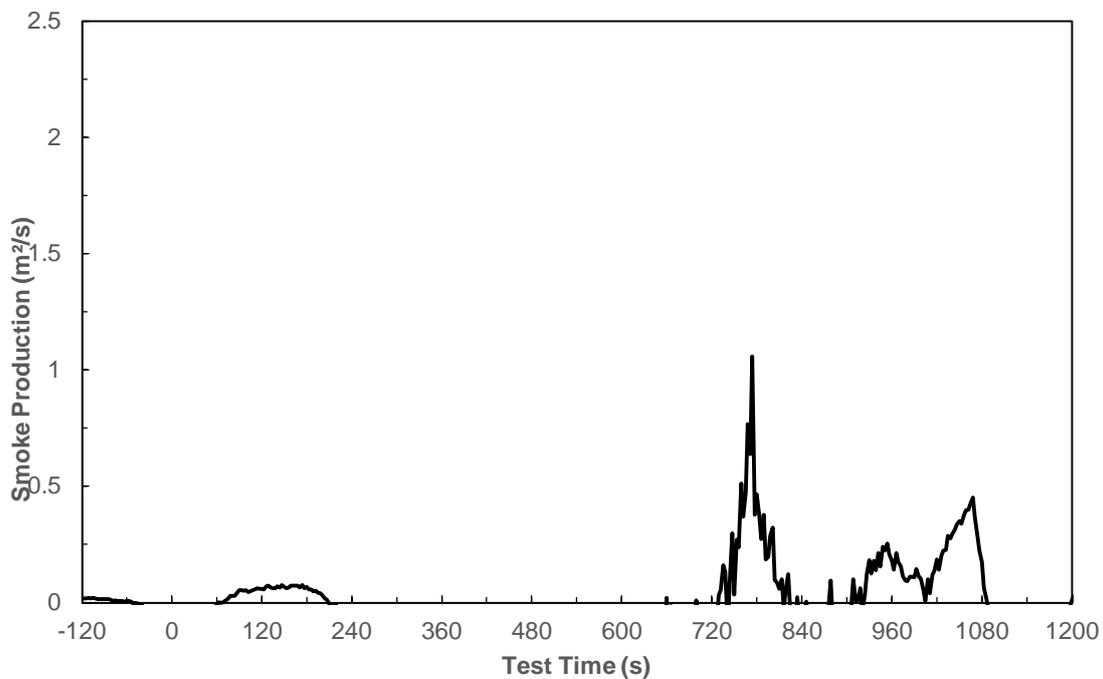
Figure 13 Production of light obscuring smoke vs time, at reference temperature and pressure

The maximum average rate of smoke growth for this material occurred at 168 seconds into the test and was found to be 0.1 m²/s. Therefore, the SMOGRA_{RC} (in m²/s² × 1000) value for the material is 0.4.

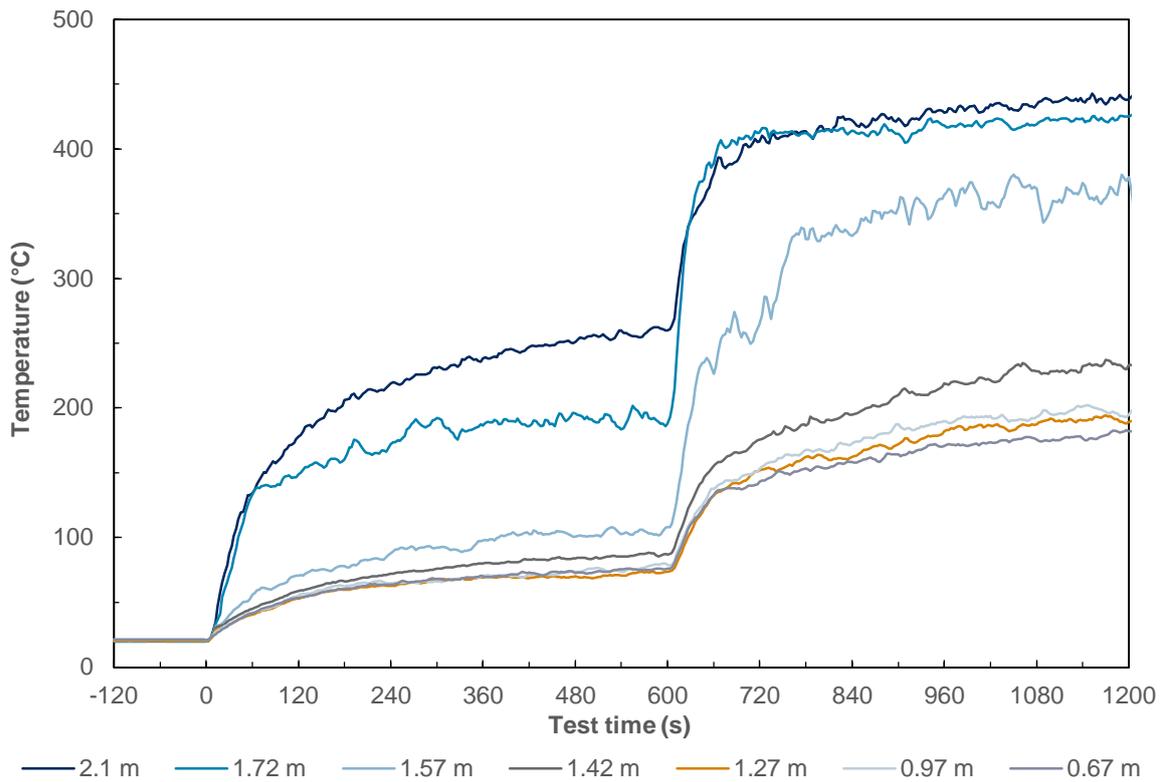
Figure 14 Temperature at the measured heights (from the floor) in the corner opposite to the burner vs time

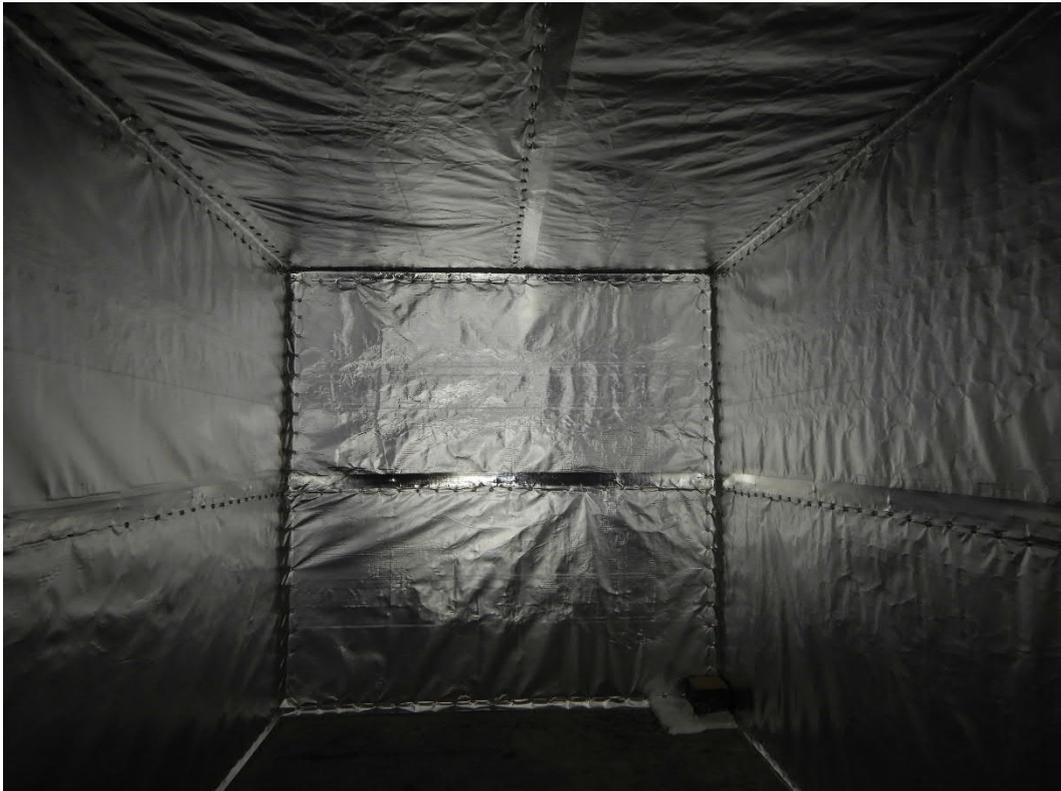
Figure 15 The specimen before the reaction to fire test

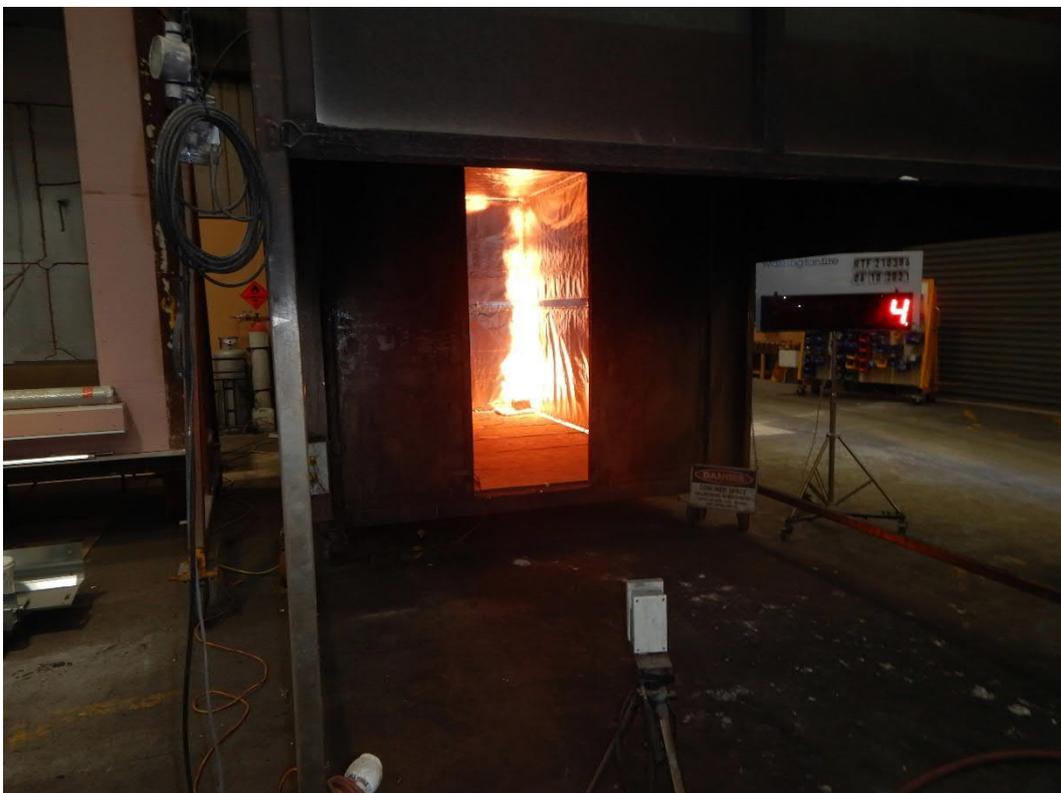
Figure 16 The specimen 4 seconds after burner ignition with the burner output of 100 kW

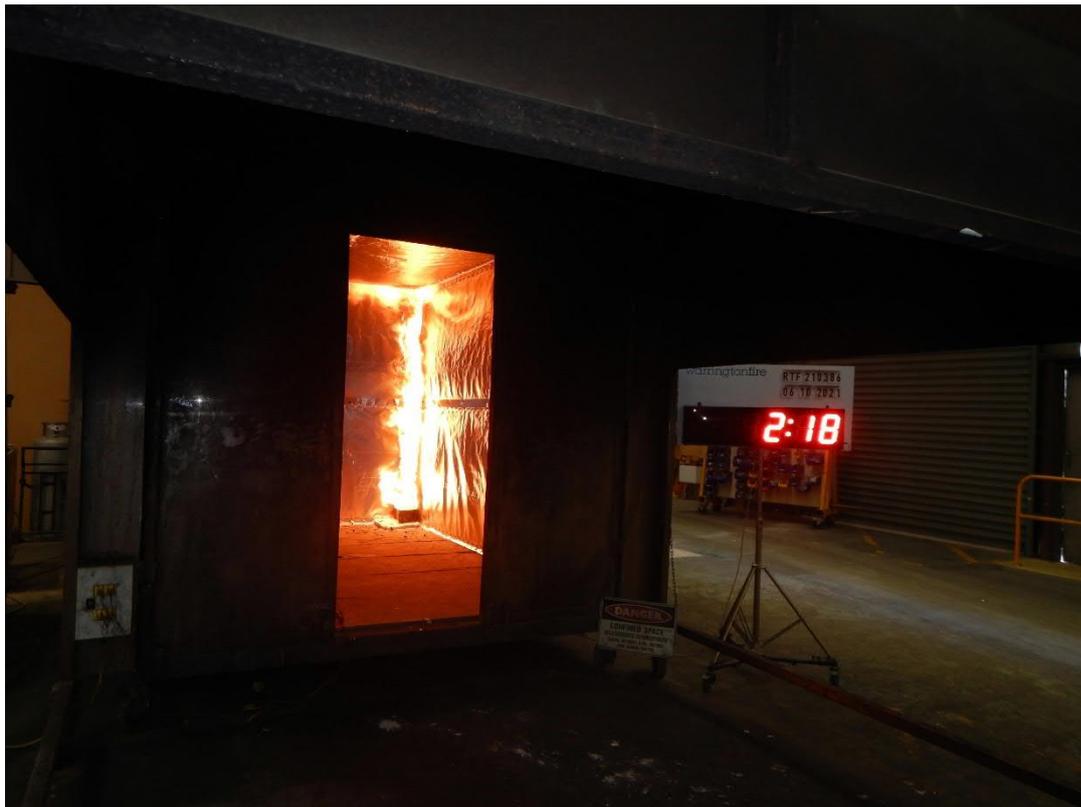
Figure 17 The specimen 2 minutes 18 seconds after burner ignition with the burner output of 100 kW

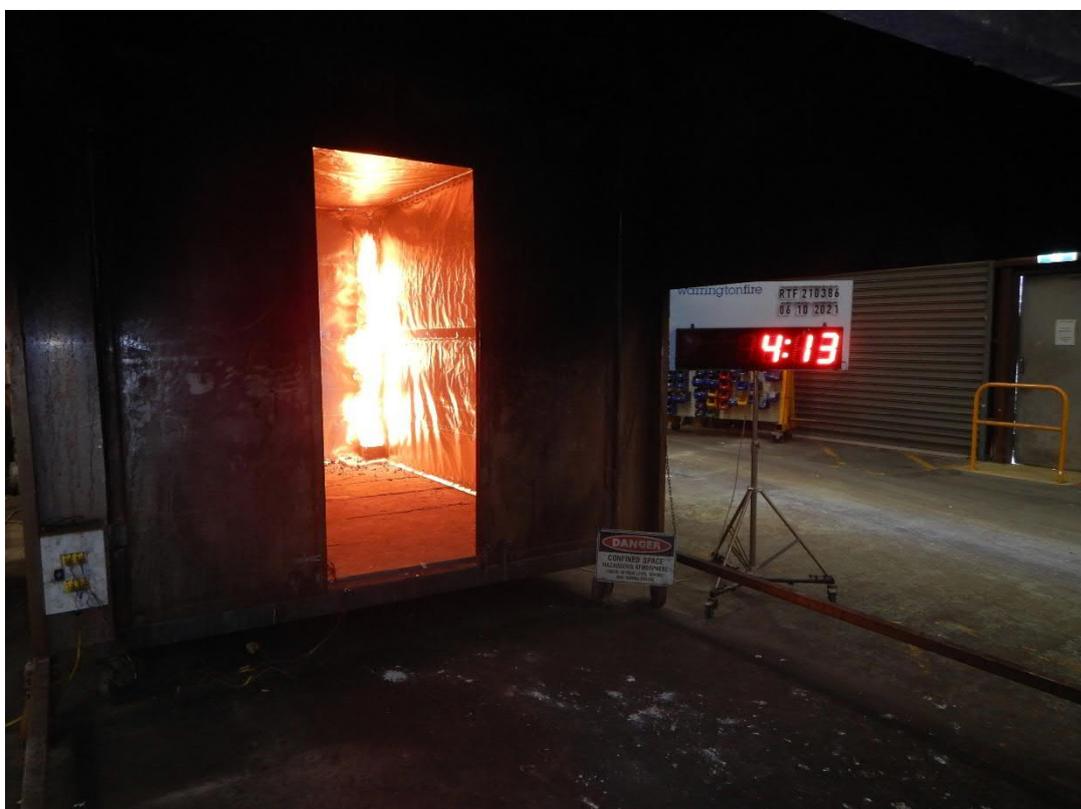
Figure 18 The specimen 4 minutes 13 seconds after burner ignition with the burner output of 100 kW

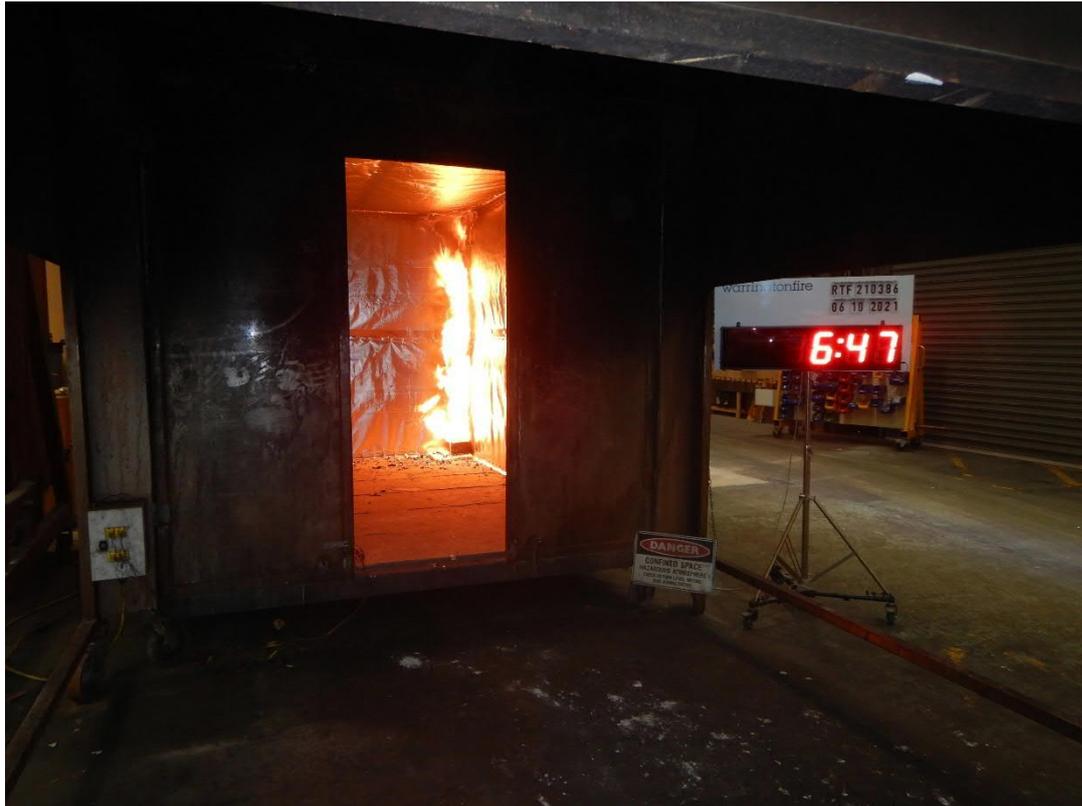
Figure 19 The specimen 6 minutes 47 seconds after burner ignition with the burner output of 100 kW

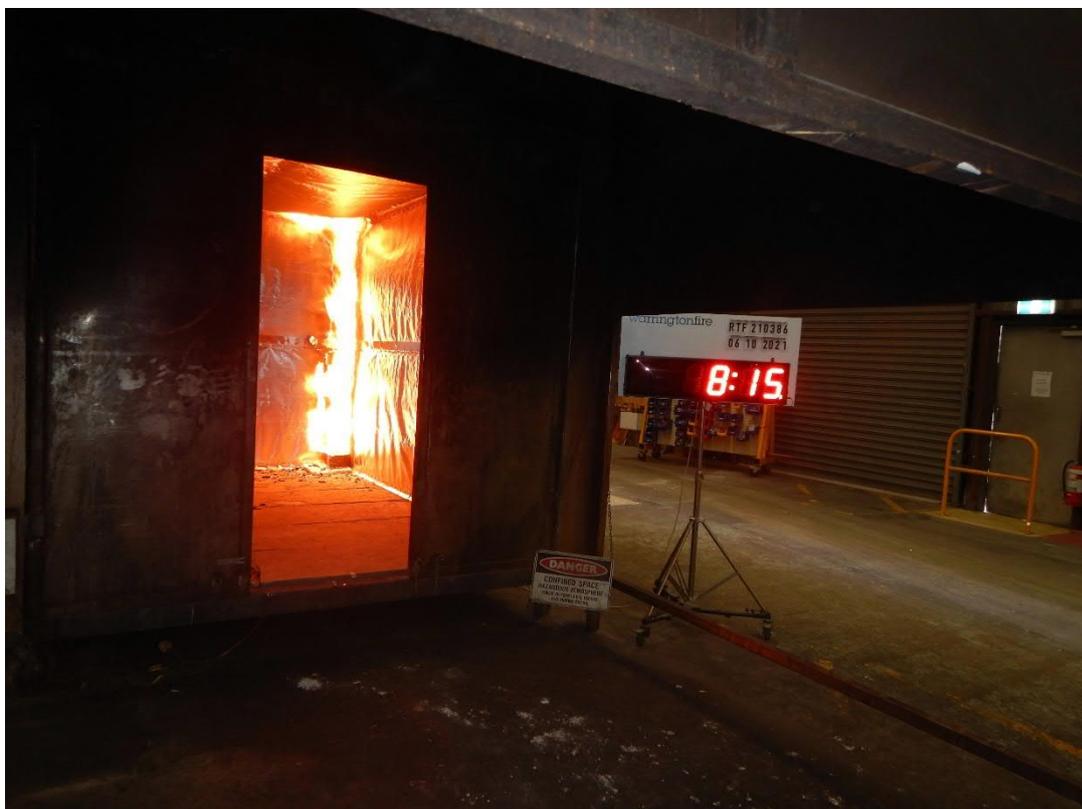
Figure 20 The specimen 8 minutes 15 seconds after burner ignition with the burner output of 100 kW

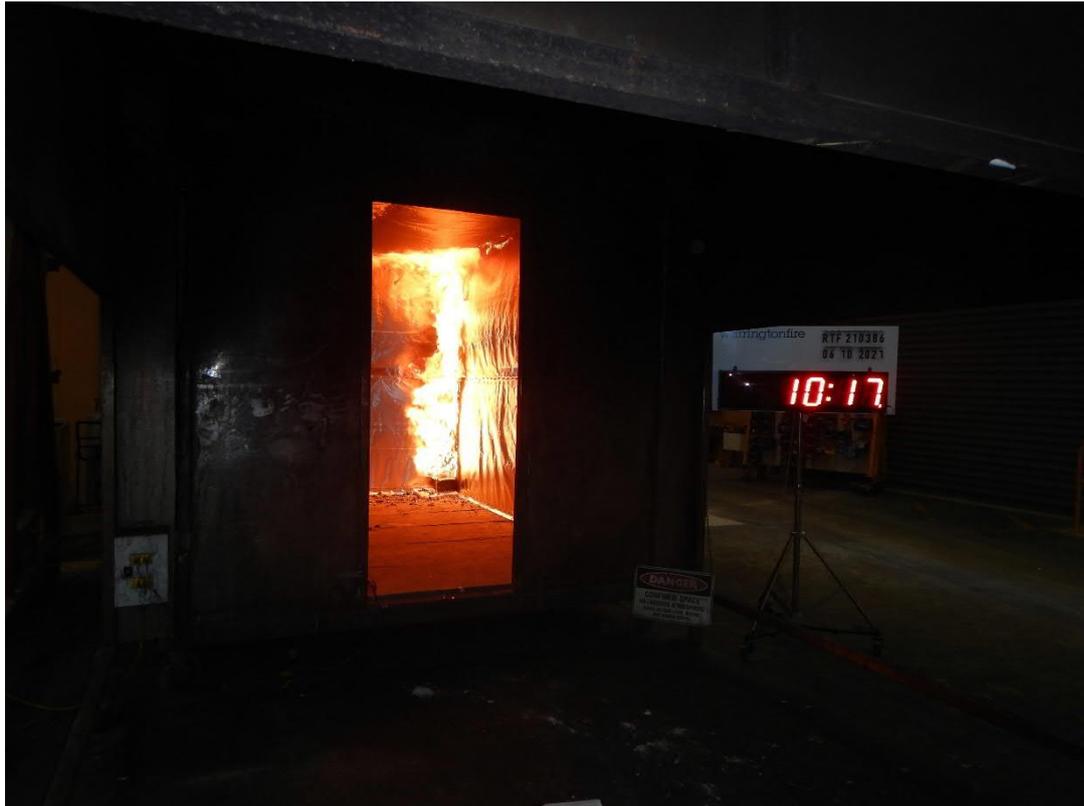
Figure 21 The specimen 17 seconds after burner output was increased to 300 kW

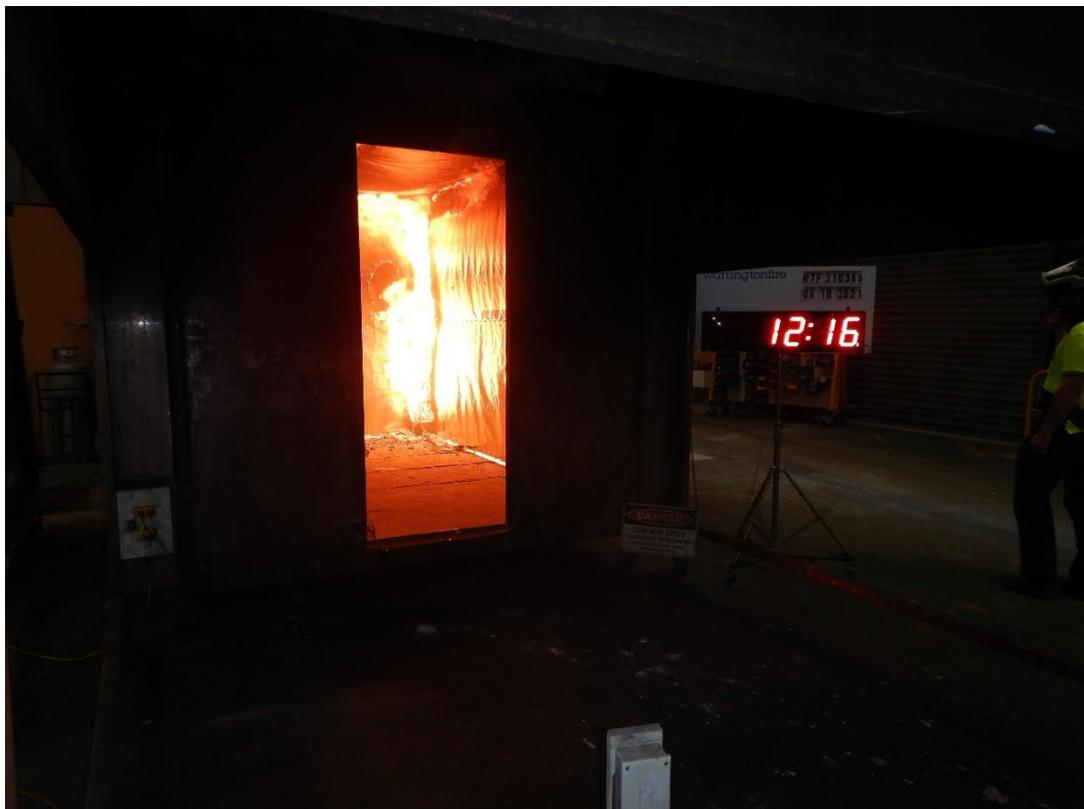
Figure 22 The specimen 2 minutes 16 seconds after burner output was increased to 300 kW

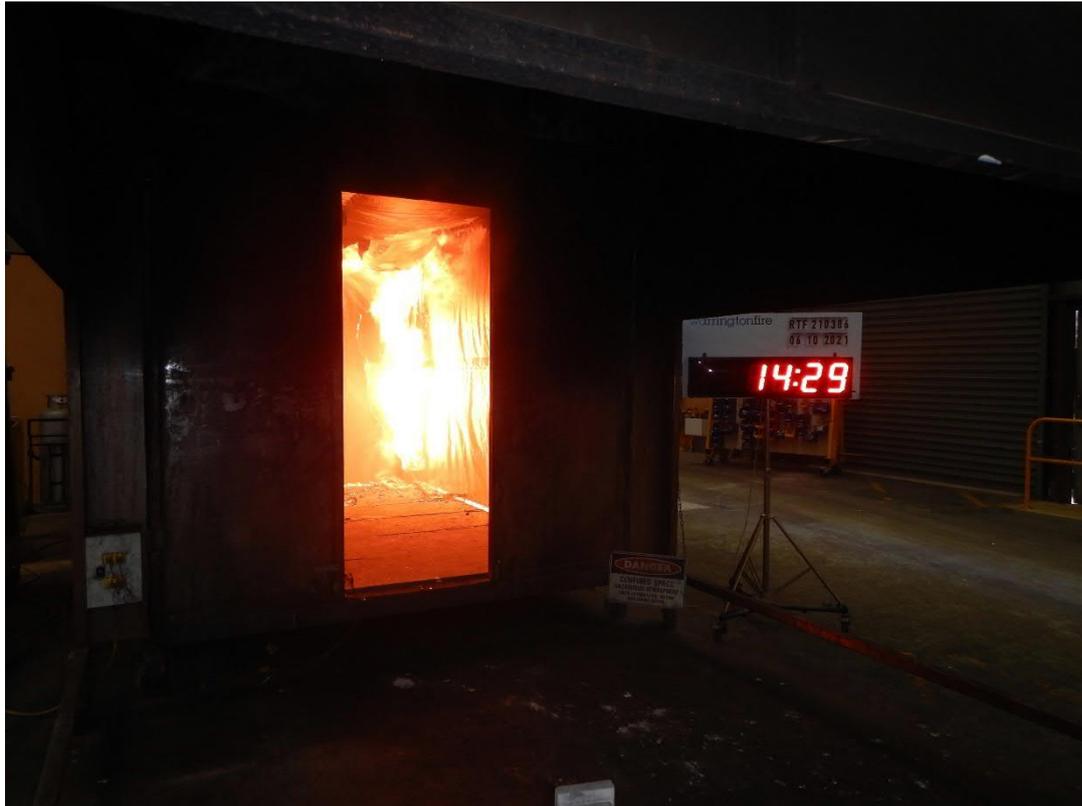
Figure 23 The specimen 4 minutes 29 seconds after burner output was increased to 300 kW
