Reaction to fire test report

Test standard: AS ISO 9705:2003 (R2016)

Product: TBA Firefly™ Intubatt® with TBA FIREFLY™ NON-COMBUSTIBLE Sarking-Non-BREATHABLE

Job number: RTF210386

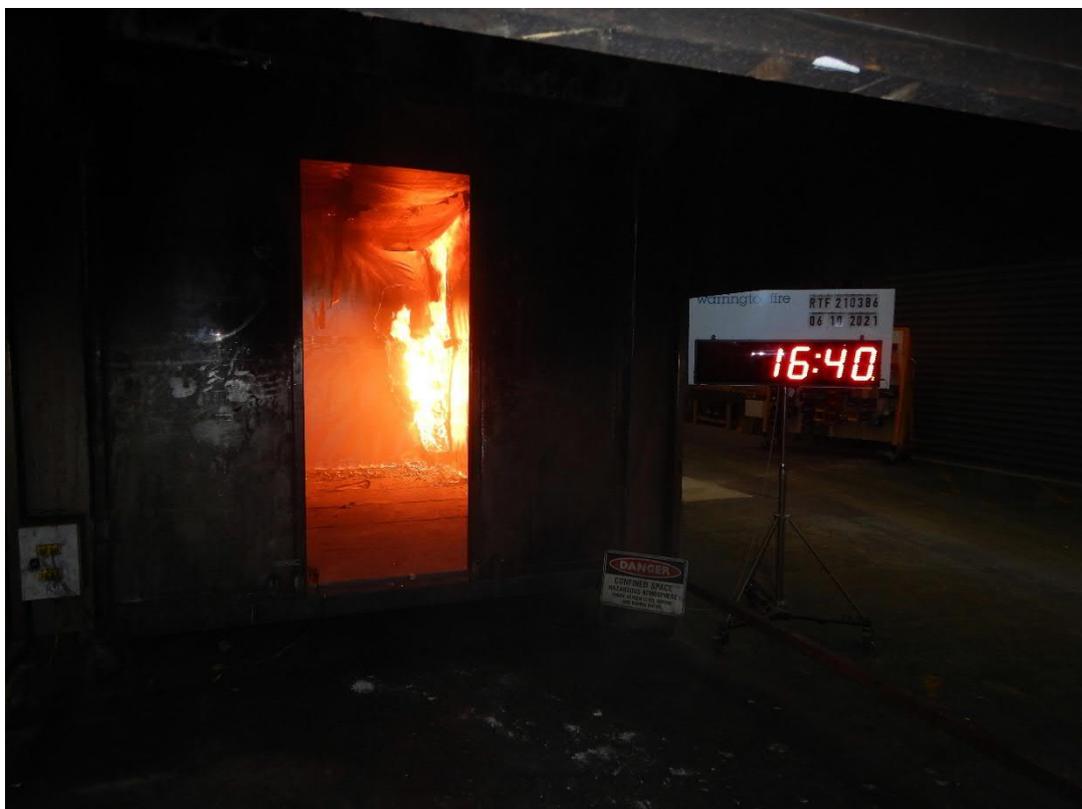
Figure 24 The specimen 6 minutes 40 seconds after burner output was increased to 300 kW

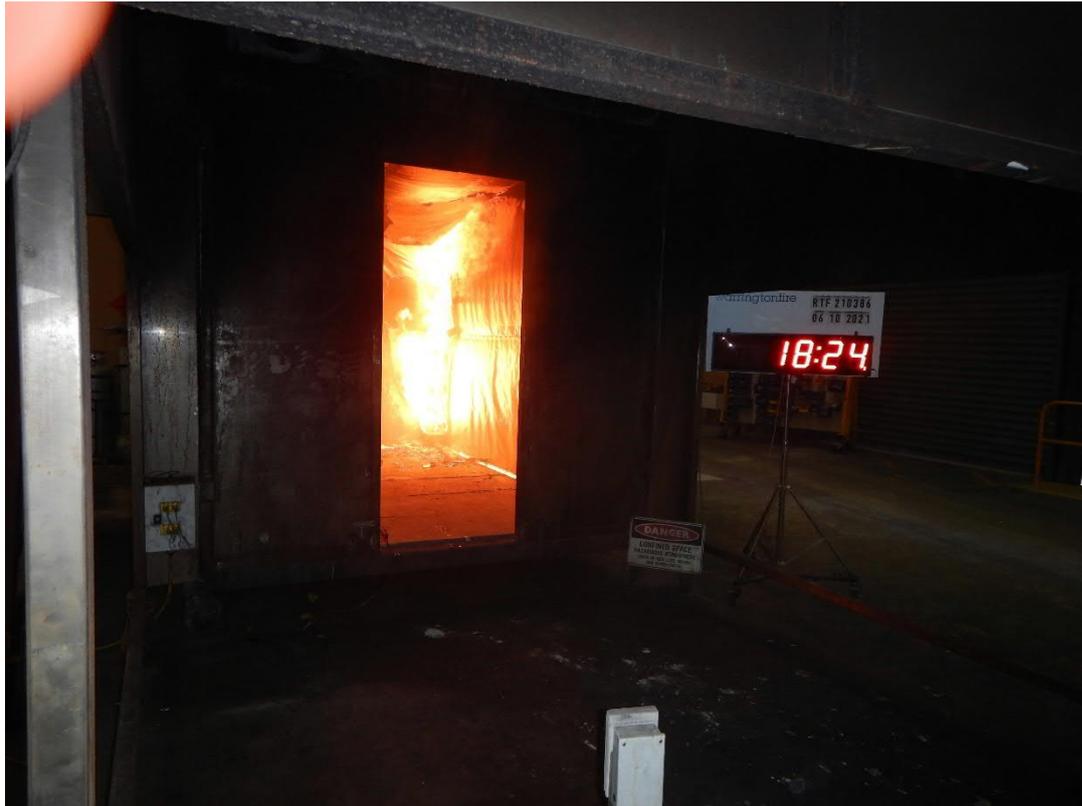
Figure 25 The specimen 8 minutes 24 seconds after burner output was increased to 300 kW

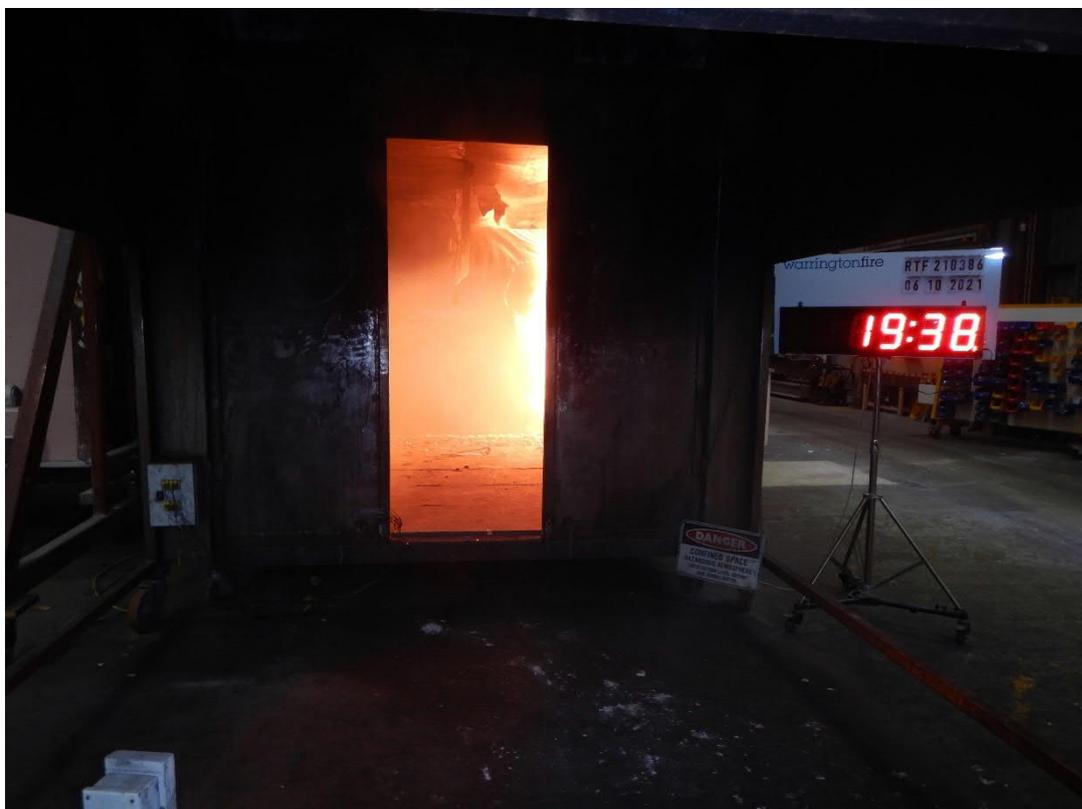
Figure 26 The specimen 9 minutes 38 seconds after burner output was increased to 300 kW

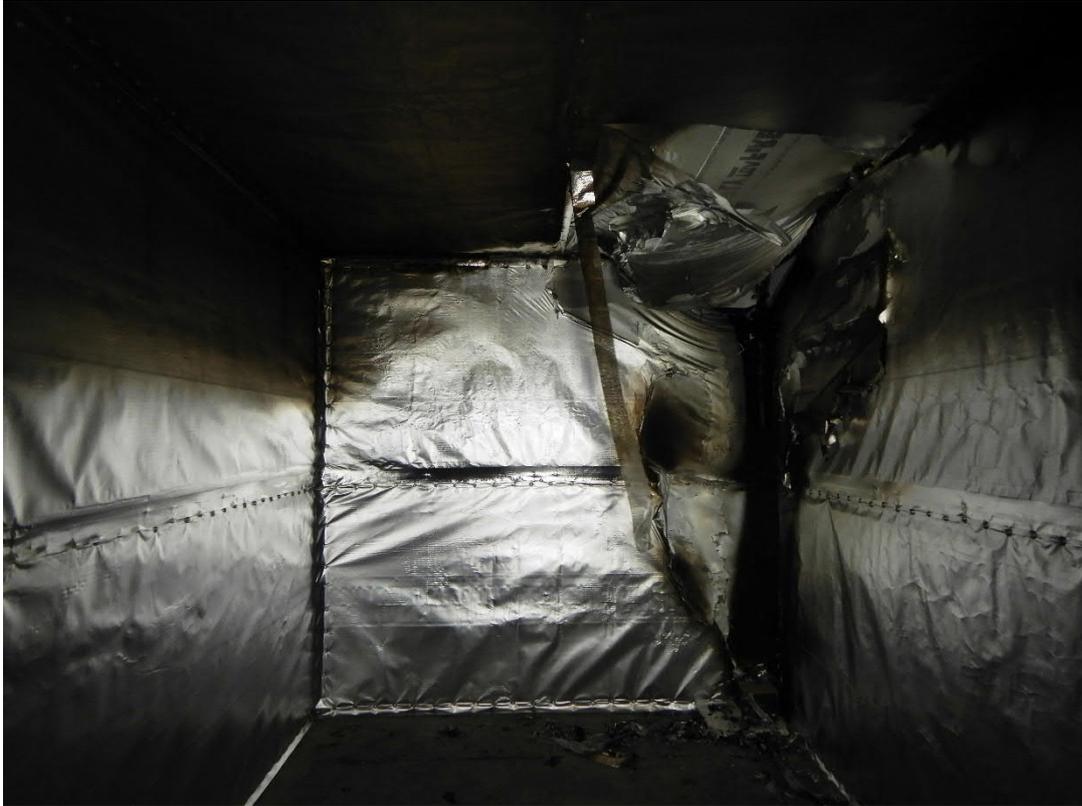
Figure 27 The specimen after the reaction to fire test
